# MICROCHIP PIC18F6390/6490/8390/8490

## PIC18F6390/6490/8390/8490 Rev. B3 Silicon Errata

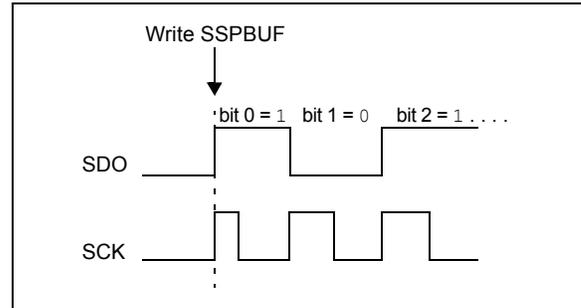
**FIGURE 1: SCK PULSE VARIATION USING TIMER2/2**

When the SPI is using Timer2/2 as the clock source, a shorter than expected SCK pulse may occur on the first bit of the transmitted/received data (Figure 1).

To avoid producing the short pulse, turn off Timer2 and clear the TMR2 register, load the SSPBUF with the data to transmit and then turn Timer2 back on. Refer to Example 4 for sample code.
